ETKİNLİK RAPORU

Etkinlik: Uluslararası ICOMOS Ahşap Komitesi (IIBC) 27. Sempozyumu – Çarşamba TSO Tanıtım ve İş Birliği Programı

IWC 2025 Annual Meeting and 27th Symposium WOODEN MOSQUES TOUR IN SAMSUN

BRIEF INFORMATION ABOUT WOODEN MOSQUES IN SAMSUN

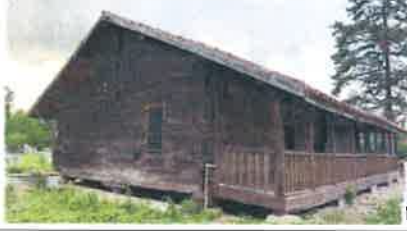
3. KUŞHANE MOSQUE

Location: Çarşamba district in Samsun	
Building date / period: 17 th century	
Date of the registration: 14.11.2003	
<p>Kuşhane Mosque is located within a large cemetery area and is believed to stand in its original location. It has lost its active function following the construction of a nearby reinforced concrete mosque. The restoration of the mosque was completed in ... and dendrochronological analysis conducted in 2025 dated its construction to ... However, to determine a more precise construction date, additional samples would be required.</p> <p>The mosque is elevated on footing stones and comprises revaqs on the east and north sides, a closed son cemaat yeri (last-comers' area) to the north, and a harim (main prayer hall). The structural system of the roof, which resembles the inverted hull of a ship, can be perceived from the interior space. This mosque is very similar with Göğceli Mosque.</p> <p>Access to the son cemaat yeri is from the north side. Air and natural light enter through distinctive openings on the east and west sides, creating a unique interior atmosphere. The roof is hipped and slopes in three directions.</p> <p>In terms of decoration, the mosque is quite modest. Simple wooden carvings are the main ornamental elements observed in the structure.</p>

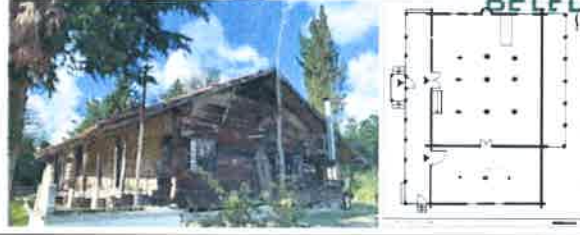
It is located in a cemetery area shared by two villages. The mosque was dendrochronologically dated by P. I. Kuniholm, just like the Göğceli Mosque. However, the results of the analyses are viewed with skepticism. The data obtained strengthens the possibility that the mosque was built in the late 15th century. Today, it is not actively used for daily prayers; it is only used after funeral services or by locals visiting the cemetery.

The mosque is elevated on footing stones. It follows a vertical plan scheme oriented in the north–south direction, with *revaqs* (arcades) on the east and west sides, and a *son cemaat yeri* (last-comers' area) on the north. A women's gallery (*kadınlar mahfili*) is located at the north end of the *harim* (main prayer hall), and it is thought to have been added later.

The construction technique of Şeyh Habil Mosque, does not allow for many openings, as in similar period buildings. The mihrab protrudes outward on the south façade of the single-storey mosque. The roof of the mosque is hipped in three directions. The mosque has a hipped roof sloping in three directions: while the roof over the *harim* is gabled in two directions, it breaks toward the north from the northern wall of the *harim*, forming the roof over the *son cemaat yeri*.

Şeyh Habil Mosque is quite simple in terms of decoration. There are simple wood carvings and painted decorations on wooden elements.

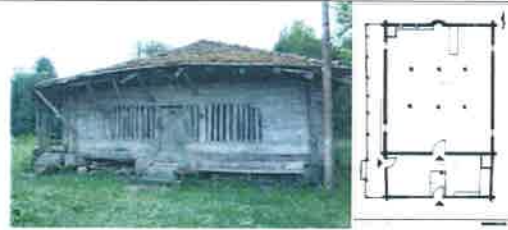
7. YENİCAMİ MOSQUE

The mosque, located in a wooded cemetery area and shared by two villages, shows signs—such as notches with engravings and paint—that suggest it may have been relocated, though no written documentation confirms this. The earliest date engraved on the mosque dates to 1178 AH (1764/65 AD), and it was traditionally dated to the 18th century. However, dendrochronological analysis completed in 2025 revised the construction date to 1591, which aligns with its architectural features. In early 2025, the restoration works of the mosque were initiated by the relevant institution.

The mosque is raised on footing stones from the ground and has a vertically oriented plan in the north–south direction, with a *revaq* on the east and a closed *son cemaat yeri* (last-comers' area) on the north.

Entry to the *son cemaat yeri* is from the north and it is seen that an arrangement was made on both sides of the entrance door for ventilation and light. The mihrab protrudes outward on the south façade of the mosque. The mosque has a hipped roof sloping in three directions: while the roof over the *harim* is gabled in two directions, it breaks toward the north from the northern wall of the *harim*, forming the roof over the *son cemaat yeri*.

Yenıcamı Mosque is quite simple in terms of decoration. There are simple wood carvings and painted decorations on wooden elements.
